MARITIME HERITAGE MINNESOTA

Minnesota Suburban Lakes Nautical Archaeology 3 Project Report: Prior Lake

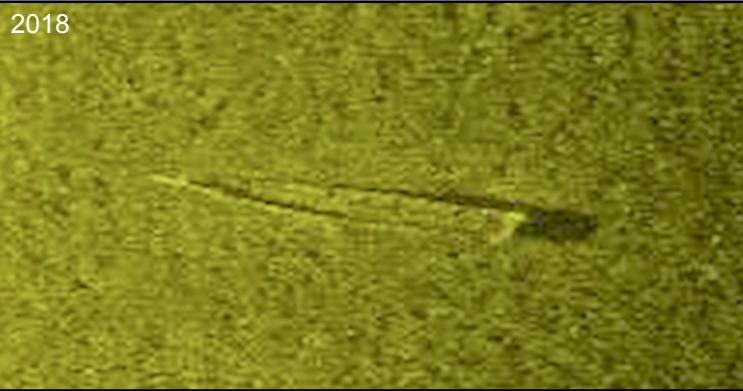
Sonar image of 21-SC-116 (MHM)

MHM recorded a sonar image of Anomaly 57 during the 2016 and 2018 surveys; the 2018 image of the anomaly clearly shows it is a small wreck. As part of the MSLNA-3 Project, Anomaly 57 was investigated using SCUBA; the Wooden Flat Bottomed Wreck is 14.50 feet long, 2.80 feet in the beam; and the depth of hold is 1.00 foot. Constructed

of wood, the wreck has a pointed bow with a stempost, square transom, hard chine, and is longitudinally planked. The port and starboard gunwales with a caprail survive forward; moving aft, the caprail has deteriorated. A rubrail survives along the vessel's sides, with some surviving white paint. The stern is intact but worn, with the upper gunwale stake offset and attached to the transom on its outer surface, in essence creating a rudimentary rubrail. Two metal through-hull fittings at gunwale-level on the inner transom probably supported the dislodged bench; the port side fitting is missing but the large through-hull bolt that held it in place is extant. The port and starboard quarters survive with upright frames at each corner that are secured with thick metal bolts with roves; these frames are rough-hewn tree branches as opposed to cut and trimmed beams. Further, bottom hull strakes are visible and a bench seat at the stern is present but it has dislodged. No frames can be discerned, but the sonar image suggests frames survive near the silt line. While no oarlocks survive, Anomaly 57 likely had them during her lifetime and a metal strap is loosely associated with the starboard side amidships; its function is unknown. Inside the hull, a jumble of beams and planks are found, along with a stanchion that may be the remnants of a mast, although that is unlikely. Due to her low freeboard, MHM suggests she was used primarily in still waters, whether for duck hunting or fishing. She is well-built, with particular attention paid to her sturdy stempost and both stern corners. In consideration of a construction date for the Wooden Flat Bottomed Row Boat Wreck, MHM contends the vessel was constructed in the 1890s. Small wooden boats on Prior Lake and other vacation destination lakes with resorts on their shores were easily accessible by rail from the Twin Cities, and large numbers of watercraft were needed for the tourist trade. Taking into account the wreck's condition, MHM contends Anomaly 57 sank around 1910. MHM acquired her Minnesota Archaeological Site Number, 21-SC-116 in January 2020.

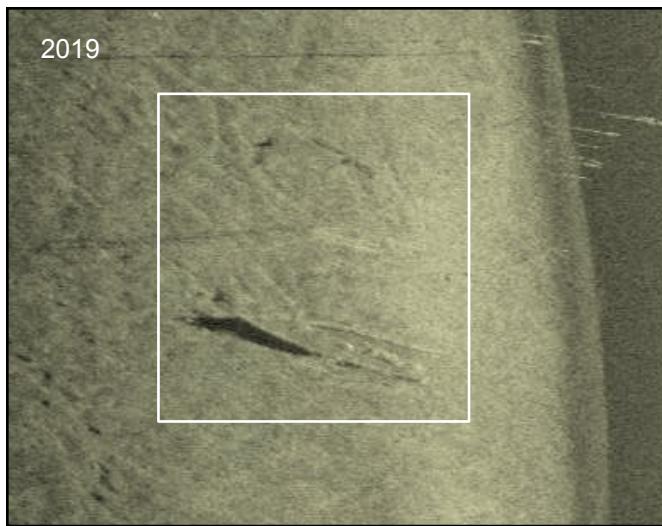
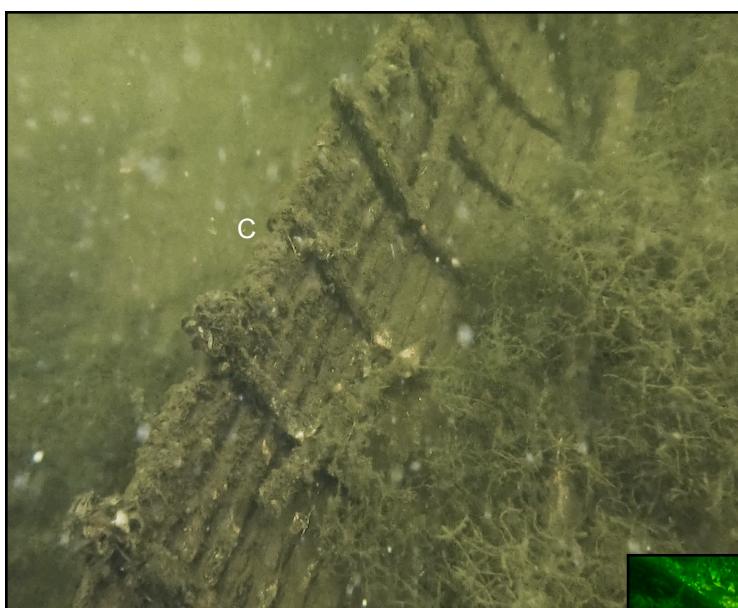
Anomaly 67 was recorded in sonar footage from 2016 but without much detail. In 2019, clear images of the Slat Wood Outboard Motor Boat Wreck were achieved during targeted sonar survey. Anomaly 67 is 13.50 feet long, 4.50 feet in the beam, has a pointed bow, and an intact stempost with a towing ring attached to it. She is carvel-built of fine, thin wooden stakes and held together with slot-headed wood screws and nails. Her gunwale is missing throughout the wreck and her square transom was dislodged from the hull and lies 11.00 feet off the starboard quarter, next to a bottle - and another bottle lies in the silt between the transom and the hull. The transom is lying with its inner face upward, with a sturdy knee attached to a trapezoidal reinforcing plank that also has a motor board attached to it at the gunwale. The rectangular motor board has 2 concentric circles pressed into it, indicators that she carried a good-sized outboard motor. The only surviving gunwale on the wreck is the top edge of the transom that angles downward to accept the motor. Thin futtocks extend above the hull's sides, visible due to the missing gunwale; they curve at the gentle turn of the bilge, becoming floors on the vessel's flat bottom. A fragmented stringer that extends the entire length of the wreck is attached to the inner starboard side of the hull; this stringer may have supported the vessel's benches that are no longer extant. A hefty splashrail runs along the outer hull on both port and starboard; on the port side it is just above the silt line. The individual outer hull stakes can be seen throughout the wreck, and they are broken off at the stern. Inside the aft portion of the hull, a metal anchor roller with a bow casting lie loose in the silt among weeds. It is arguable that this set of bow gear were once attached to Anomaly 67. The inner and outer hull was covered with white primer or paint topped by a layer of light blue paint. MHM contends the vessel was constructed around 1920 by a skilled boatwright. Anomaly 67's working life would be limited by her wooden construction, and a working life of 15 years is reasonable. Therefore, MHM contends the Slat Wood Outboard Motor Boat Wreck sank around 1935, a possible 15-year life on the water. MHM acquired her Minnesota Archaeological Site Number, 21-SC-112 in January 2020.

- A. Stern
- B. Starboard Quarter
- C. Starboard Amidships
- D. Starboard Forward
- E. Bow

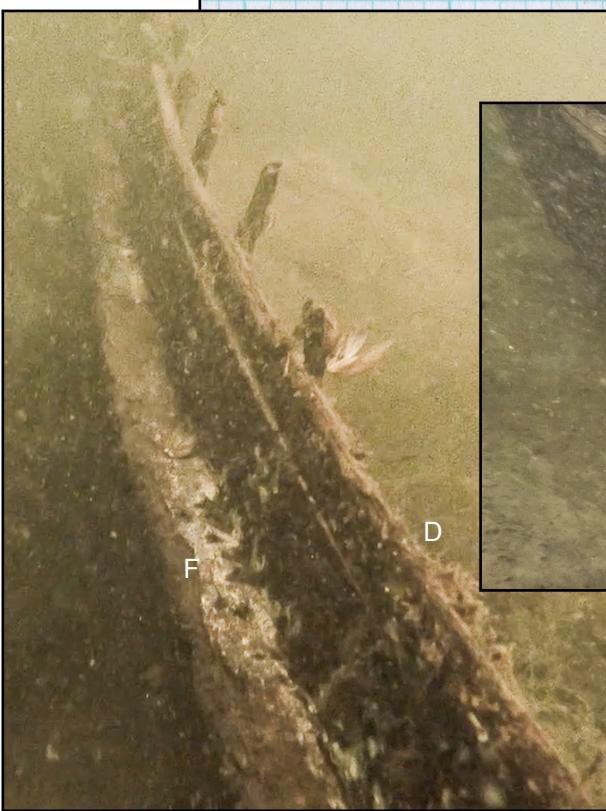
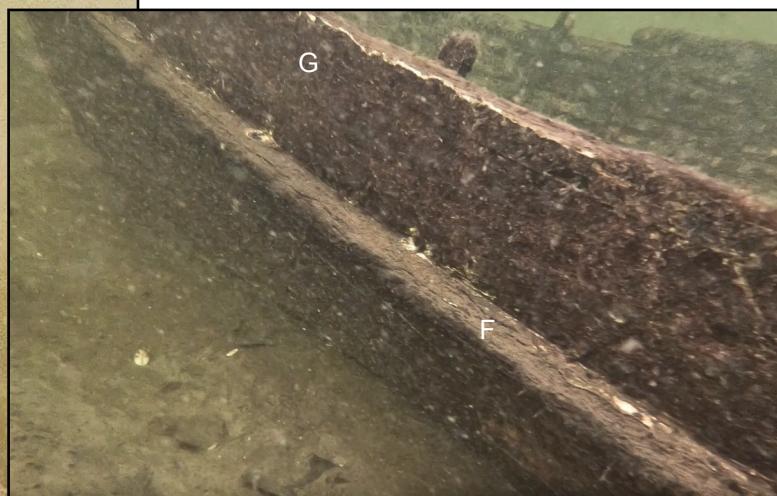
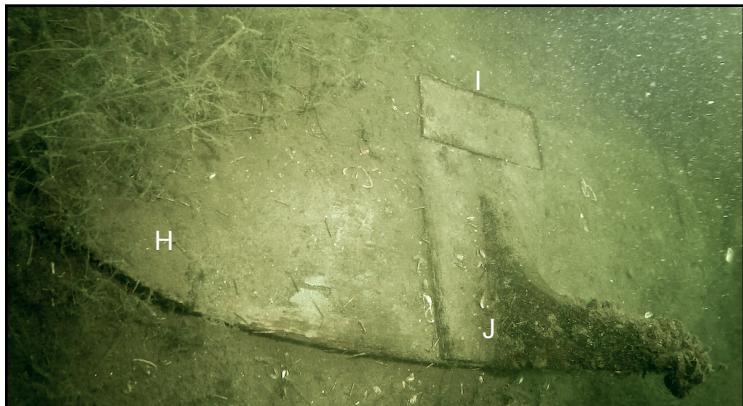
H. Inner Transom
I. Motor Board
J. Stern Knee

The Stern Knee is
notched to fit over the
last 3 floors.

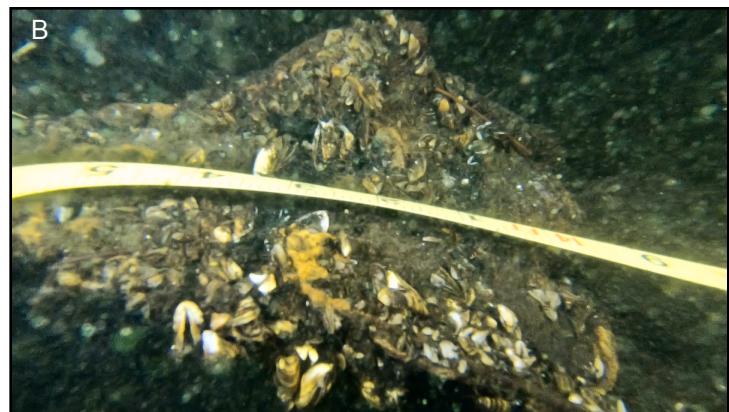
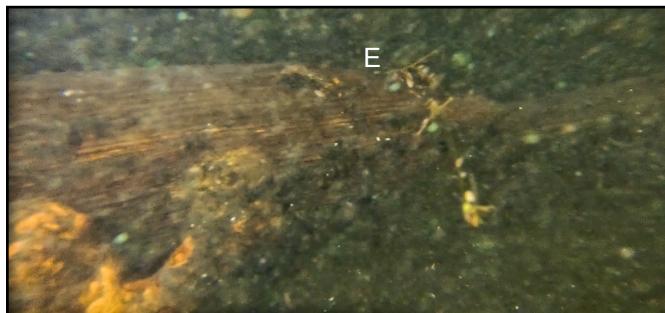
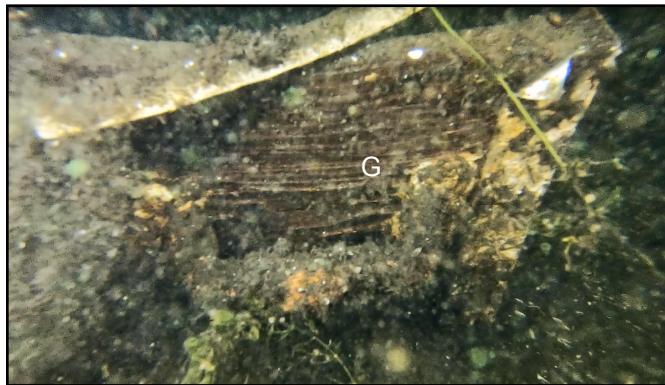
- D. Port Quarter and Handle
- E. Port Stern Gunwale
- F. Starboard Stern Gunwale
- G. Starboard Quarter, Handle, and Metal Strips

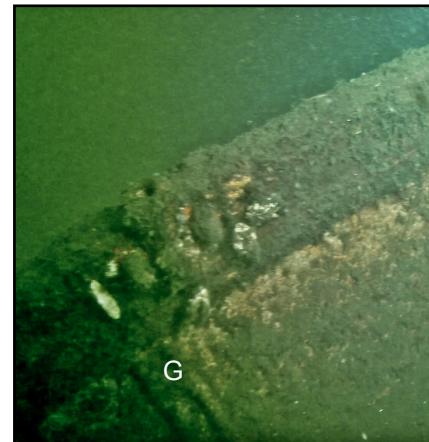
The Steel Outboard Motor Boat Wreck has 4 wooden benches: 1 at the bow, 2 amidships, and 1 at the stern. Anomaly 74 was covered in white primer or paint, along with an outer layer of red paint. In considering the wreck's construction, MHM has discerned 2 seams - starboard amidships and the port quarter - created by the joining of metal sheets through welding or brazing. MHM contends Anomaly 74 was constructed by welding since the process required lower temperatures than brazing, and therefore was an easier method to master, particularly if the vessel was a home-build. In consideration of a construction date for the wreck, MHM contends the vessel was fabricated around 1920; small steel boats were commonly used beginning in the 1890s, but the processes of brazing and welding were not commonly used in watercraft construction until after World War I. Anomaly 74's working life would be longer than a wooden boat, at least pertaining to hull integrity due to rot. Therefore, taking the deteriorated condition of the wreck into account, MHM contends Anomaly 74 sank around 1940, a possible 20-year life on the water.

F. Port Quarter Welded Seam
G. Starboard Amidships Channel Frame
H. Starboard Forward Welded Seam
I. Starboard Side Quarter Red & White Paint

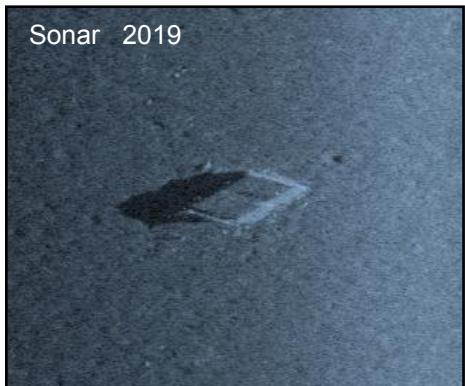
MHM recorded sonar images of Anomaly 30 in 2016, 2018, and 2019 and surmised it is a fish house, an identification that was proven during the MSLNA-3 Project. The wood and metal Fish House 1 landed upside-down when it fell through the ice; the square fishing 'hole' in the house's bottom is exposed. It measures approximately 8.00 feet long and 6.00 feet wide, and it stands 4.00 feet off the bottom; MHM suggests there is another 3.00 - 4.00 feet of the house below the silt, making the house 7.00 or 8.00 feet in height. Metal attachments on one end of the house were likely used to move the house on the ice. Anomaly 30 is a protected submerged maritime cultural resource.

Part of the bottom frame of Fish House 1; poor visibility did not allow for good images.

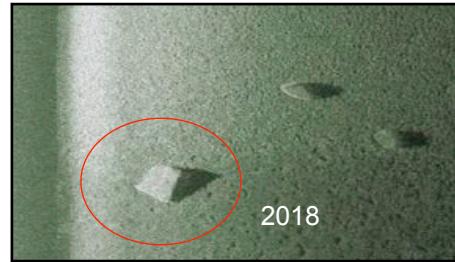
MHM recorded sonar images of Anomaly 8.2 in 2016 and 2018, initially surmising that it is a dock box that was separated from its original location. However, with the identification of Anomaly 30, and a re-examination of the sonar images, MHM has determined that Anomaly 8.2 is a partially-buried fish house that is lying on its side. Therefore, Fish House 2 does not require SCUBA reconnaissance unless further information about this particular submerged cultural resource is derived from historical research. Another argument that supports MHM's identification of the site without using SCUBA is its location; it is near a spread of a significant stone field and would be an excellent fishing spot. MHM contends Fish House 2 is roughly the same size as Fish House 1, but it is lying at an angle and is significantly more buried. Anomaly 8.2 is a protected submerged maritime cultural resource.
